ELECTREX CO., INC.

Infrared Preventive Maintenance Inspection

Sample

Job Number E-0000

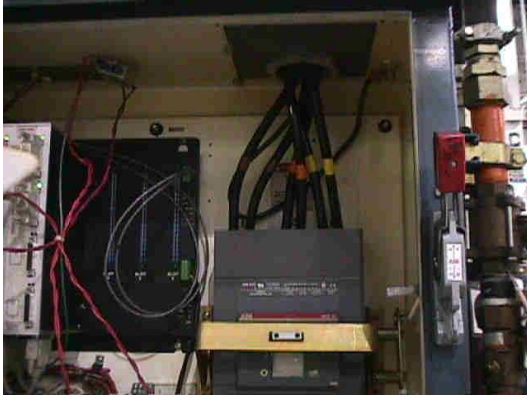
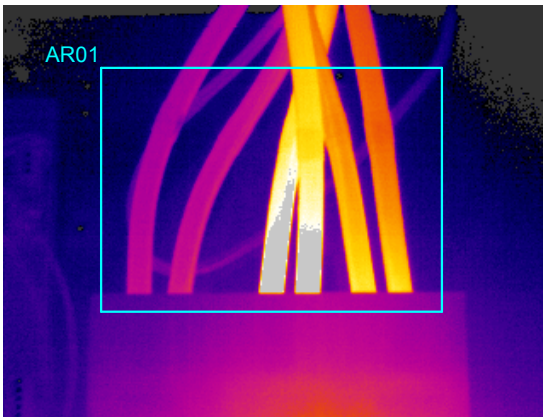
Location:	Rear Compartment Assembly
Equipment:	RC-200 Weld Controller B
Item:	Wires & Terminations
Date:	11/9/1999
Time:	11:55:45 AM

Object Distance	5.0 ft
Ambient Temp.	78.0°F
Max. Temperature:	127.6°F
Area 1 Max. Temp.	127.6°F

Developed overheating. Should be repaired as soon as possible.

Problem Severity is in Red	Repair Time Frame	Based on Delta T Method
Classification 1	Next Scheduled Shutdown	1 - 15 Degrees Fahrenheit
Classification 2	As Available	16 - 35 Degrees Fahrenheit
Classification 3	ASAP	36 - 55 Degrees Fahrenheit
Classification 4	Critical	Above 56 Degrees Fahrenheit

Amprobe Loads, Shutdown Equipment, Confirm Proper Conductor Size, Confirm Proper Overcurrent Protection, Disassemble, Inspect, Clean & Tighten.

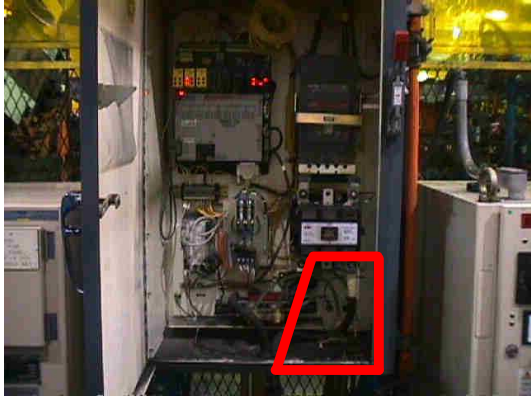
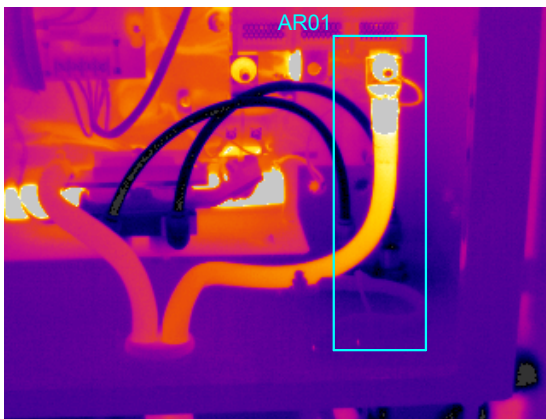
Location:	Ladder Assembly
Equipment:	LA 300 R-30 Weld Controller E
Item:	Wires & Termination
Date:	11/9/1999
Time:	12:13:58 PM

Object Distance	5.0 ft
Ambient Temp.	78.0°F
Max. Temperature:	334.0°F
Area 1 Max. Temp.	153.9°F

Acute overheating. Immediate repairs required.

Problem Severity is in Red	Repair Time Frame	Based on Delta T Method
Classification 1	Next Scheduled Shutdown	1 - 15 Degrees Fahrenheit
Classification 2	As Available	16 - 35 Degrees Fahrenheit
Classification 3	ASAP	36 - 55 Degrees Fahrenheit
Classification 4	Critical	Above 56 Degrees Fahrenheit

Amprobe Loads, Shutdown Equipment, Confirm Proper Conductor Size, Confirm Proper Overcurrent Protection, Disassemble, Inspect, Replace Crimp Lug and Hardware, Clean & Tighten.

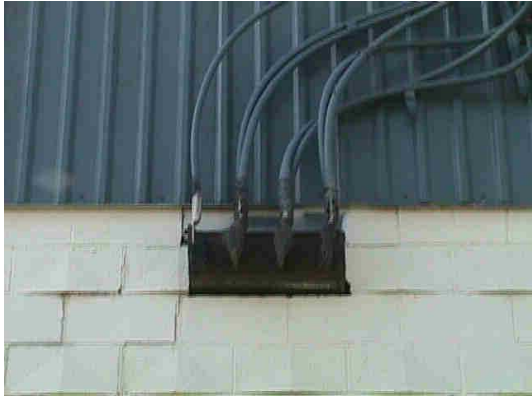
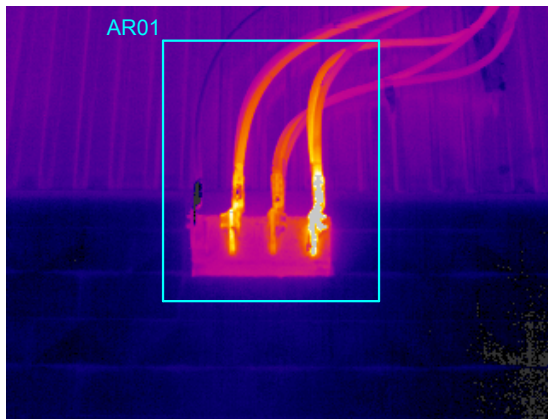
Location:	North Wall (Outside)
Equipment:	Riser for 240V Service
Item:	Riser & Wires
Date:	5/28/1999
Time:	9:36:42 AM

Object Distance	15.0 ft
Ambient Temp.	80.0°F
Max. Temperature:	214.1°F
Area 1 Max. Temp.	214.1°F

Acute Overheating. Immediate Repairs Required.

Problem Severity is in Red	Repair Time Frame	Based on Delta T Method
Classification 1	Next Scheduled Shutdown	1 - 15 Degrees Fahrenheit
Classification 2	As Available	16 - 35 Degrees Fahrenheit
Classification 3	ASAP	36 - 55 Degrees Fahrenheit
Classification 4	Critical	Above 56 Degrees Fahrenheit

Amprobe Loads, Shutdown Equipment, Confirm Proper Conductor Size, Confirm Proper Overcurrent Protection, Disassemble, Inspect, Replace Crimp Lug and Hardware, Clean & Tighten.

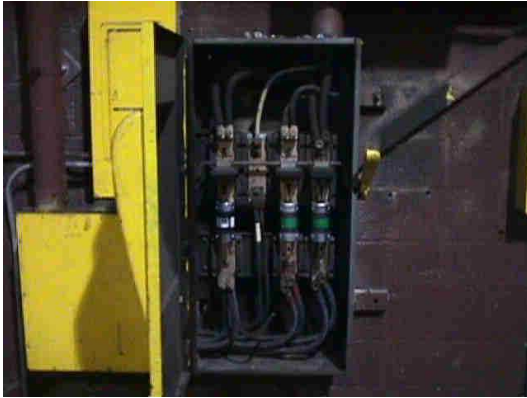
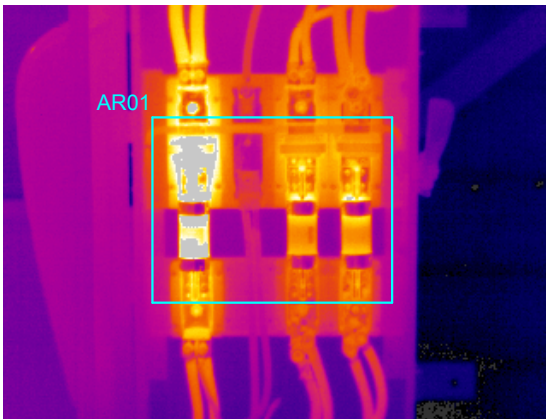
Location:	Near Switchgear
Equipment:	Building Main Disconnect
Item:	Fuse, Fuse Holder, Terminations
Date:	3/28/2001
Time:	11:32:02 AM

Object Distance	5.0 ft
Ambient Temp.	78.0°F
Max. Temperature:	134.8°F
Area 1 Max. Temp.	134.8°F

Acute overheating. Immediate repairs required.

Problem Severity is in Red	Repair Time Frame	Based on Delta T Method
Classification 1	Next Scheduled Shutdown	1 - 15 Degrees Fahrenheit
Classification 2	As Available	16 - 35 Degrees Fahrenheit
Classification 3	ASAP	36 - 55 Degrees Fahrenheit
Classification 4	Critical	Above 56 Degrees Fahrenheit

Amprobe Loads, Shutdown Equipment, Confirm Proper Conductor Size, Confirm Proper Overcurrent Protection, Disassemble, Inspect, Replace Fuse and Fuse Contacts, Clean & Tighten.

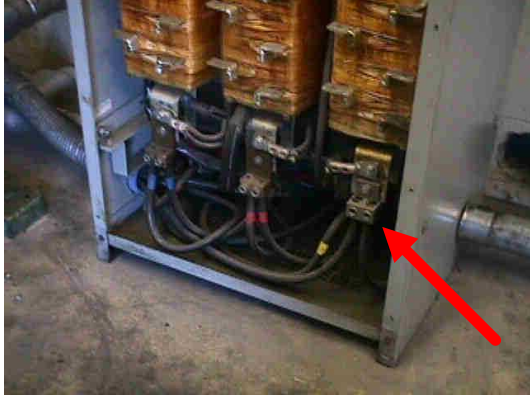
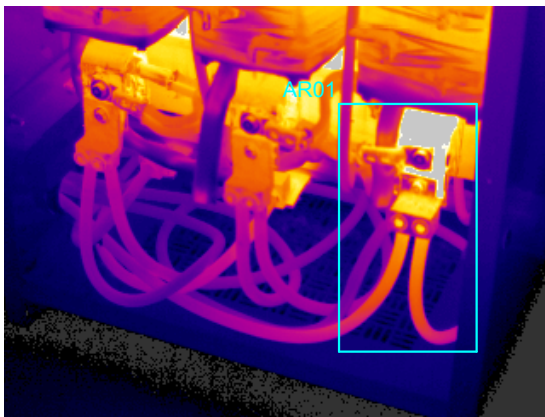
Location:	Air Comp. Room
Equipment:	300 KVA T-Former (Air Comp.)
Item:	Terminations, Wires, & Lug
Date:	6/15/1999
Time:	1:10:59 PM

Object Distance	3.0 ft
Ambient Temp.	78.3°F
Max. Temperature:	219.4°F
Area 1 Max. Temp.	219.4°F

Acute overheating. Immediate repairs required.

Problem Severity is in Red	Repair Time Frame	Based on Delta T Method
Classification 1	Next Scheduled Shutdown	100 - 115 Degrees Fahrenheit
Classification 2	As Available	116 - 130 Degrees Fahrenheit
Classification 3	ASAP	131 - 140 Degrees Fahrenheit
Classification 4	Critical	Above 141 Degrees Fahrenheit

Amprobe Loads, Shutdown Equipment, Confirm Proper Conductor Size, Confirm Proper Overcurrent Protection, Disassemble, Inspect, Replace Bus Bar from Phase C Coil, Clean & Tighten.

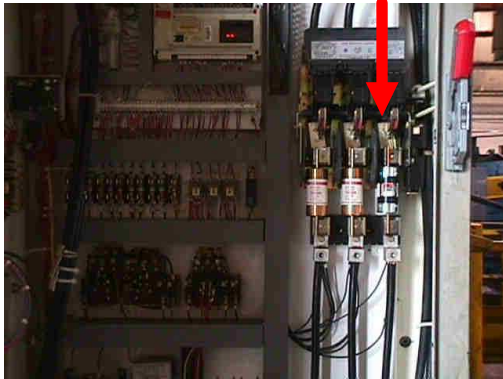
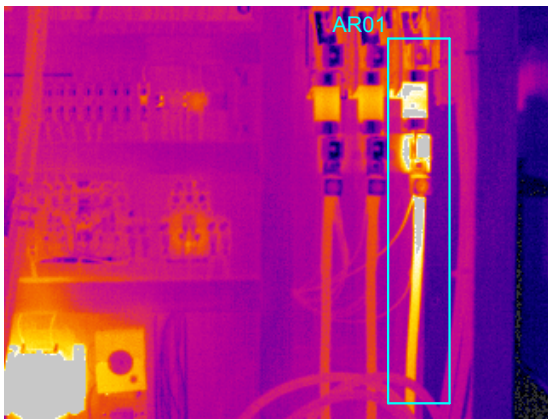
Location:	Press #1
Equipment:	Control Panel
Item:	Fuses, Wire & Terminations
Date:	6/16/1999
Time:	8:57:46 AM

Object Distance	5.0 ft
Ambient Temp.	81.0°F
Max. Temperature:	131.9°F
Area 1 Max. Temp.	102.5°F

Second Stage of Overheating. Should be Attended to at First Opportune Moment.

Problem Severity is in Red	Repair Time Frame	Based on Delta T Method
Classification 1	Next Scheduled Shutdown	1 - 15 Degrees Fahrenheit
Classification 2	As Available	16 - 35 Degrees Fahrenheit
Classification 3	ASAP	36 - 55 Degrees Fahrenheit
Classification 4	Critical	Above 56 Degrees Fahrenheit

Amprobe Loads, Shutdown Equipment, Confirm Proper Conductor Size, Confirm Proper Overcurrent Protection, Disassemble, Inspect, Replace Fuse and Fuse Contacts, Clean & Tighten.

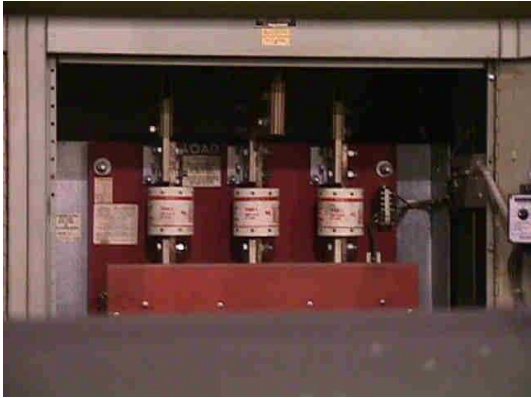
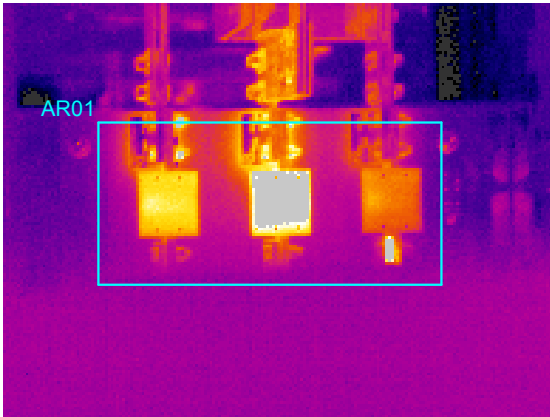
Location:	4000A Welding Switchgear
Equipment:	Welding Duct C Main
Item:	Fuse
Date:	10/27/1999
Time:	11:33:25 AM

Object Distance	5.0 ft
Ambient Temp.	68.5°F
Max. Temperature:	137.0°F
Area 1 Max. Temp.	137.0°F

Acute overheating. Immediate repairs required.

Problem Severity is in Red	Repair Time Frame	Based on Delta T Method
Classification 1	Next Scheduled Shutdown	1 - 15 Degrees Fahrenheit
Classification 2	As Available	16 - 35 Degrees Fahrenheit
Classification 3	ASAP	36 - 55 Degrees Fahrenheit
Classification 4	Critical	Above 56 Degrees Fahrenheit

Amprobe Loads, Shutdown Equipment, Confirm Proper Conductor Size, Confirm Proper Overcurrent Protection, Disassemble, Inspect, Replace Phase B Fuse, Clean & Tighten.

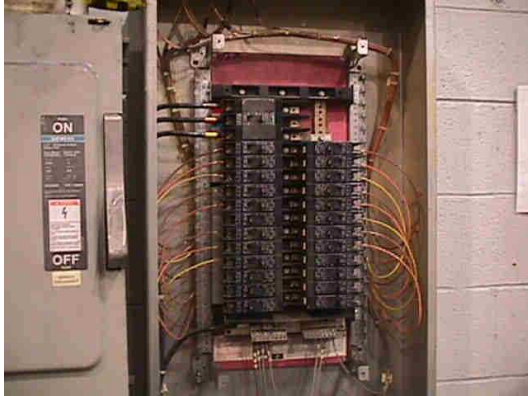
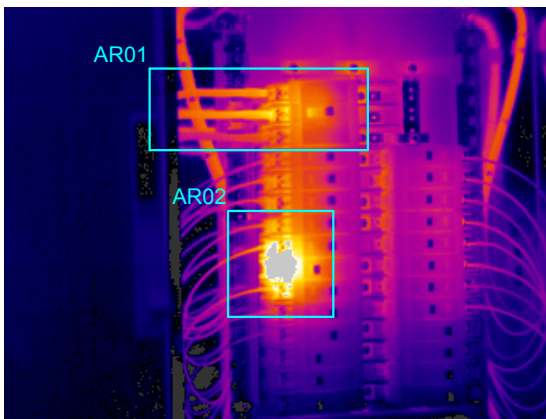
Location:	SouthEast Wall
Equipment:	100A 480V L.P.
Item:	Breaker, Termination, Wire
Date:	10/27/1999
Time:	12:02:28 PM

Object Distance	5.0 ft
Ambient Temp.	68.0°F
Max. Temperature:	211.6°F
Area 1 Max. Temp.	143.0°F
Area 2 Max. Temp.	211.6°F

Acute overheating. Immediate repairs required.

Problem Severity is in Red	Repair Time Frame	Based on Delta T Method
Classification 1	Next Scheduled Shutdown	1 - 15 Degrees Fahrenheit
Classification 2	As Available	16 - 35 Degrees Fahrenheit
Classification 3	ASAP	36 - 55 Degrees Fahrenheit
Classification 4	Critical	Above 56 Degrees Fahrenheit

Amprobe Loads, Shutdown Equipment, Confirm Proper Conductor Size, Confirm Proper Overcurrent Protection, Disassemble, Inspect, Replace Necessary Breakers, Clean & Tighten.

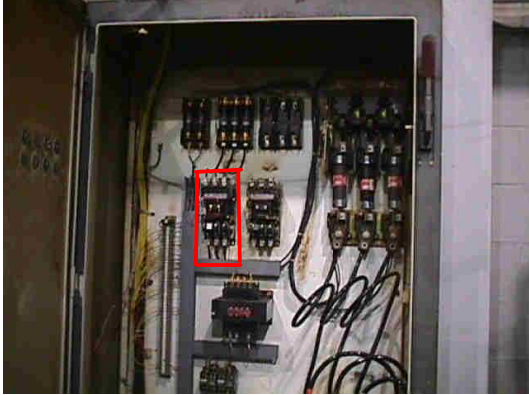
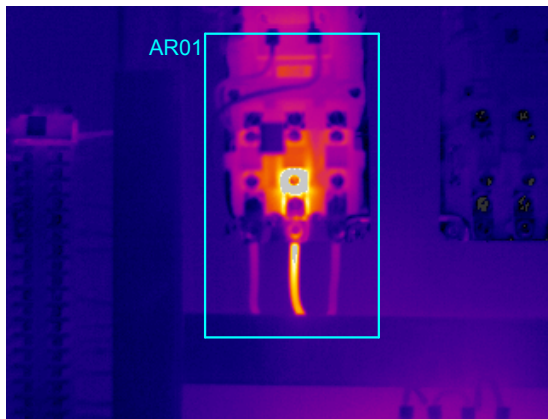
Location:	East Wall
Equipment:	Cooling Tower Control Panel
Item:	Wires, Terminations
Date:	10/27/1999
Time:	1:09:58 PM

Object Distance	5.0 ft
Ambient Temp.	78.0°F
Max. Temperature:	213.2°F
Area 1 Max. Temp.	213.2°F

Acute overheating. Immediate repairs required.

Problem Severity is in Red	Repair Time Frame	Based on Delta T Method
Classification 1	Next Scheduled Shutdown	1 - 15 Degrees Fahrenheit
Classification 2	As Available	16 - 35 Degrees Fahrenheit
Classification 3	ASAP	36 - 55 Degrees Fahrenheit
Classification 4	Critical	Above 56 Degrees Fahrenheit

Amprobe Loads, Shutdown Equipment, Confirm Proper Conductor Size, Confirm Proper Overcurrent Protection, Disassemble, Inspect, Replace Overload and Internal Contacts, Clean & Tighten.

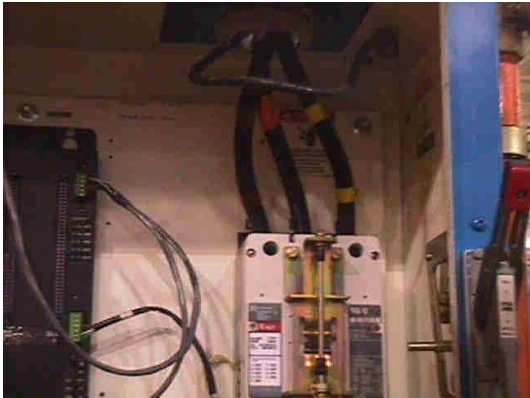
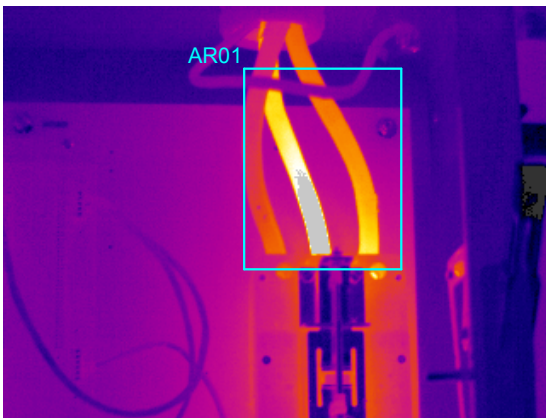
Inspected Equipment:
CP E4 RR-40R

Location:	Rear Rail RH
Equipment:	CP E4 RR-40R
Item:	Wire, & Termination
Date:	10/28/1999
Time:	10:16:34 AM

Object Distance	5.0 ft
Ambient Temp.	71.0°F
Max. Temperature:	135.1°F
Area 1 Max. Temp.	135.1°F

Fault Description Acute overheating. Immediate repairs required.

Problem Severity is in Red	Repair Time Frame	Based on Delta T Method
Classification 1	Next Scheduled Shutdown	1 - 15 Degrees Fahrenheit
Classification 2	As Available	16 - 35 Degrees Fahrenheit
Classification 3	ASAP	36 - 55 Degrees Fahrenheit
Classification 4	Critical	Above 56 Degrees Fahrenheit

Recommendation
 Amprobe Loads, Shutdown Equipment, Confirm Proper Conductor Size, Confirm Proper Overcurrent Protection, Disassemble, Inspect, Clean & Tighten.

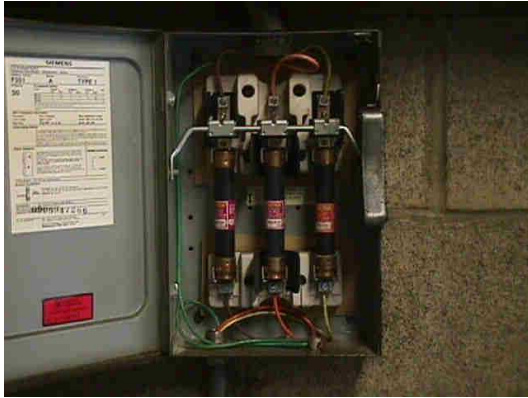
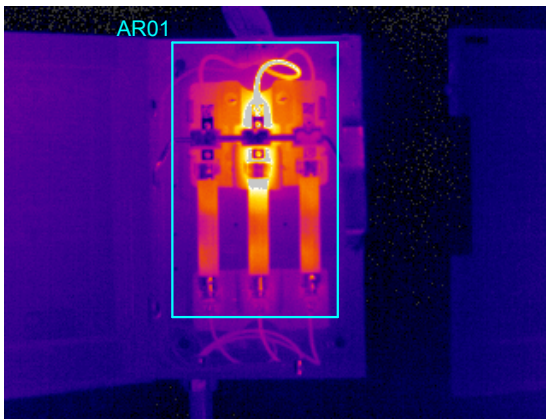
Location:	Air Compressor Room (East)
Equipment:	30A Disc. for Air Comp. Refrige. Unit
Item:	Fuses, Terminations, & Wires
Date:	6/16/1999
Time:	1:43:08 PM

Object Distance	5.0 ft
Ambient Temp.	80.6°F
Max. Temperature:	162.1°F
Area 1 Max. Temp.	162.1°F

Acute overheating. Immediate repairs required.

Problem Severity is in Red	Repair Time Frame	Based on Delta T Method
Classification 1	Next Scheduled Shutdown	1 - 15 Degrees Fahrenheit
Classification 2	As Available	16 - 35 Degrees Fahrenheit
Classification 3	ASAP	36 - 55 Degrees Fahrenheit
Classification 4	Critical	Above 56 Degrees Fahrenheit

Amprobe Loads, Shutdown Equipment, Confirm Proper Conductor Size, Confirm Proper Overcurrent Protection, Disassemble, Inspect, Replace Defective Disconnect.

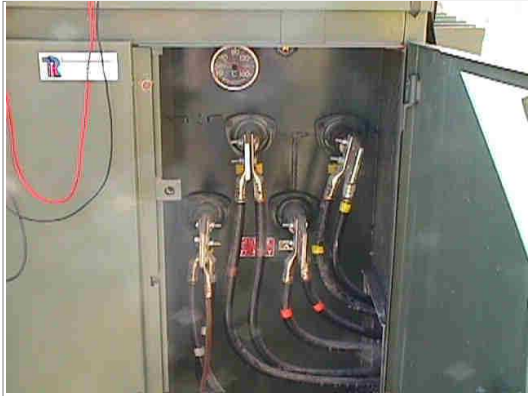
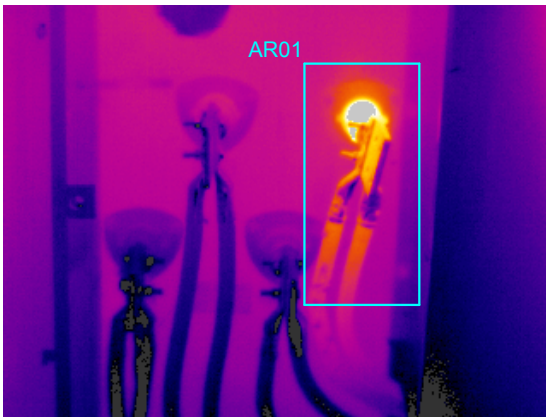
Inspected Equipment:
500 KVA Transformer

Location:	Outside Feeding Bldg. B
Equipment:	500 KVA Transformer
Item:	Transformer
Date:	9/18/2000
Time:	10:53:32 AM

Object Distance	5.0 ft
Ambient Temp.	72.0°F
Max. Temperature:	143.1°F
Area 1 Max. Temp.	143.1°F

Acute overheating. Immediate repairs required.

Problem Severity is in Red	Repair Time Frame	Based on Delta T Method
Classification 1	Next Scheduled Shutdown	1 - 15 Degrees Fahrenheit
Classification 2	As Available	16 - 35 Degrees Fahrenheit
Classification 3	ASAP	36 - 55 Degrees Fahrenheit
Classification 4	Critical	Above 56 Degrees Fahrenheit

Amprobe Loads, Shutdown Equipment, Confirm Proper Conductor Size, Confirm Proper Overcurrent Protection, Disassemble, Inspect, Replace Transformer Immediately.
